Investigating worn surfaces of nanoscale TiAlN/VN multilayer coating using FIB and TEM

Abstract. TiAlN/VN multilayer coatings exhibit excellent dry sliding wear resistance and low friction coefficient, believed to be associated with the formation of tribo-films comprising Magnéli phases such as V_2O_5 . In order to investigate this hypothesis, dry sliding wear of TiAlN/VN coatings was undertaken against Al_2O_3 . Focused ion beam was used to generate site-specific TEM specimens. A thin (2-20nm) tribo-film was observed at the worn surface, with occasional ‘roll-like’ wear debris (ϕ 5-40nm). Both were amorphous and contained the same Ti, Al and V ratio as the coating, but with the nitrogen largely replaced by oxygen. No evidence of Magnéli phases was found.

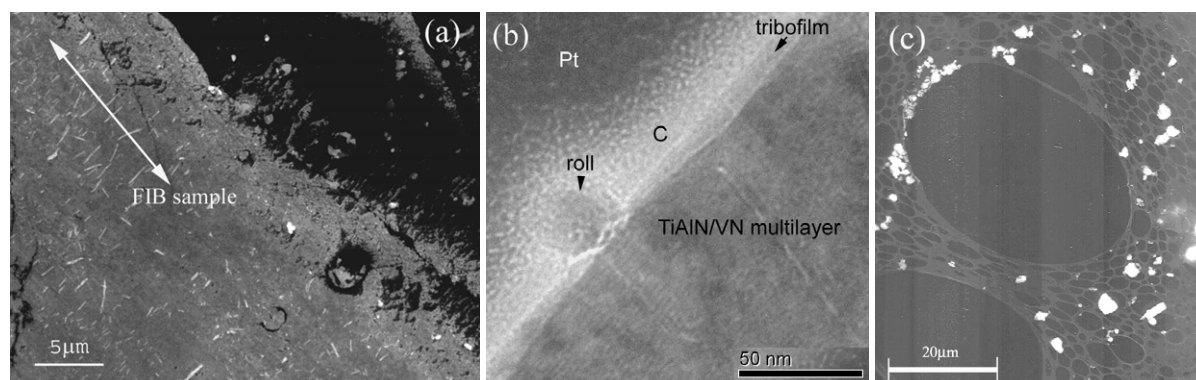
Fig.1a shows a typical scanning electron microscopy (SEM) plan-view of the worn surface. The wear track was smooth, around $100\mu\text{m}$ wide with wear debris piled up on either side. Within the wear track 'roll'-like debris was present, with the long axis of the roll perpendicular to the sliding direction on top the track. Similar rolls have been widely reported for the mild wear of hard materials, e.g. in the sliding wear of $\text{SiC-Al}_2\text{O}_3$ nanocomposites [4], but their structure and origin is still a matter of debate. Longitudinal TEM cross sections were extracted using FIB as indicated by the double arrowed bar, in order to study the worn surface, including these rolls. Fig.1b shows a zero loss filtered image of a cross section of worn surface. It comprises the multilayer coating, surface tribo-film, carbon and Pt deposition. The tribo-film is amorphous and between 2-20nm thick. A few roll-like wear debris particles were preserved at the coating surface in the FIB section. They are also amorphous, with a diameter between 5-40nm, attached to the surface tribo-film with loose amorphous material (Fig.1b). Table 1 gives the composition of the various positions as determined by EDS, which showed a similar ratio of Al, Ti and V for all the debris compared to the bulk. Loose wear debris was also picked up from the wear track for examination in the TEM (Fig. 1c). This included rolls and more irregular shaped particles. The composition of the loose wear debris exhibited a greater scatter than found at the worn surfaces in the FIB prepared TEM specimen. Due to overlapping of OK and VL lines in EDS, EELS was employed to analyse O and N in these areas.

Figure 1. (a) SEM micrograph of the worn surface and roll-like wear debris. (b) Zero loss filtered image of a cross section of worn surfaces. (c) TEM micrograph of loose wear debris supported on a carbon film.

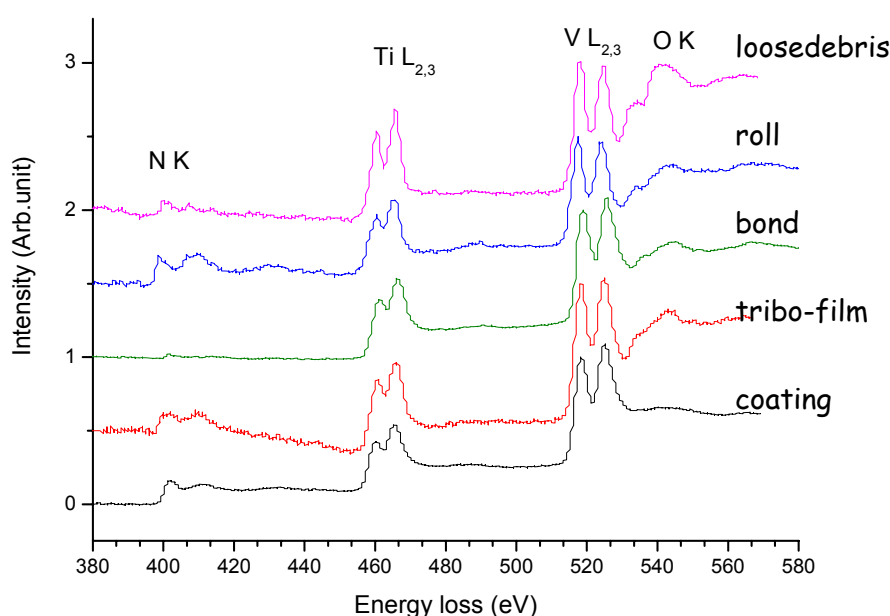
The sample prepared by FIB generally had a thickness $t > 0.5\lambda$ (λ , mean free path). However, the worn surfaces region was slightly thinner and were around $t = 0.5\lambda$. Fig.2 compares normalized and background subtracted EEL spectra from coating, worn surface, bond, rolls and loose debris. N K, Ti $L_{2,3}$, V $L_{2,3}$ and O K edges are all evident in these regions suggesting a form of $TiAlVN_xO_y$ (Al is not included in a spectrum here as the Al K is at 1560eV, but was present as determined by EDS). N intensity decreased in loose wear debris compared to the worn surface regions attached to a coating, in conjunction with a significant rise in O, but the Ti was constant. V $L_2:L_3$ changes ratio from the coating to the worn surface, in association with the appearance of the O K-edge, indicating progressive oxidation of V begins at the worn surface. The changing of $VL_{2,3}$ is also associated with the N K, indicating a variation in the degree of sub-stoichiometry, which is common in VN_x compounds [5]. However, further investigation of the near edge fine structure would require spectroscopy at superior energy resolution.

Fig.2 Experimental EEL Spectra from coating, worn surface, bond, roll-like and loose debris.

Fig.3 shows the EFTEM images of the roll-like debris separated from the worn surface by the thin amorphous tribo-film. Table 2 lists the energy windows and slit widths used to form these images. The thickness map in conjunction with the t/λ profile (position is highlighted in the thickness map) indicated that the area is too thick for the 3-window method and therefore jump ratio maps were obtained to minimize the effect of diffraction contrast/plural scattering. N K, O K and C K maps roughly indicated the location of the coating, the tribo-film and roll-like wear debris, the areas that had been oxidized, and the C protecting layer. However, note the O map includes overlapping information from the OK and V $L_{2,3}$, as shown by the apparent presence of O in the coating. In this respect, EEL data from individual point is more useful, Fig.2.

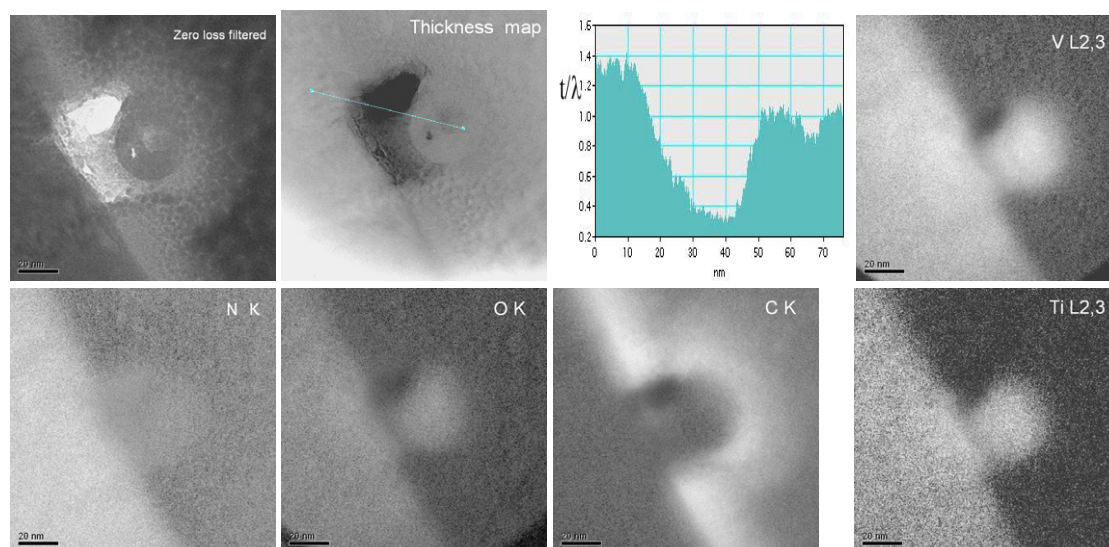
Figure 3. Zero loss energy filtered image of a roll-like particle (cross-section) attached to worn surface with loose amorphous material. Thickness map with t/λ ratio profile from the line highlighted in thickness map. EFTEM jump ratio images suggest that the roll was O-, V- and Ti-rich.

friction is likely to be associated with the amorphous structure and uniform surface coverage. The rolls are believed to be associated with the periodic detachment of the tribo-film, followed by ‘rolling-up’ as a result of residual stresses [6]. Again, this work is the first to produce a direct section through the rolls, and we have found no evidence that they form from rolling up of a detached film, rather they have a constant structure throughout their core.

Table 2 Energy windows for EFTEM maps in Fig.3
